Design, Installation, and Retrofit of Doors, Windows, and Shutters

HURRICANES IRMA AND MARIA IN THE U.S. VIRGIN ISLANDS *Recovery Advisory 4, March 2018*

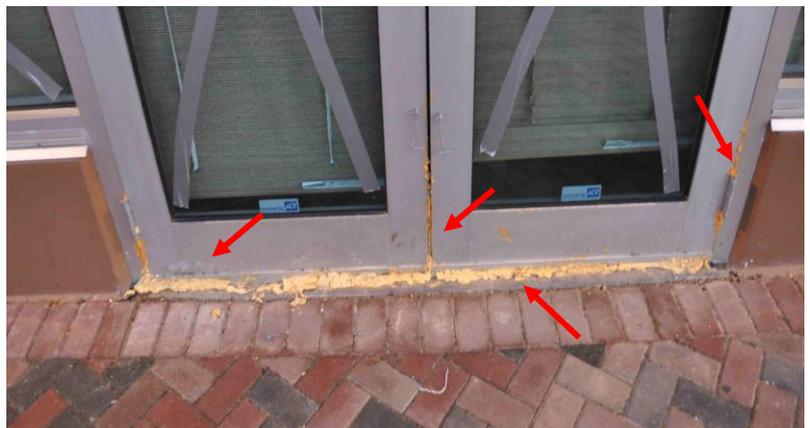
Figure 1. Expanding foam insulation was applied at gaps around and between these doors (red arrows).

- Adjust door weatherstripping to confirm a tight fit.
- Deploy shutters at doors and windows that are intended to be protected from wind-borne debris.
- Consider applying expanding foam insulation (available in aerosol cans) at door sill gaps and jambs (Figure 1) to avoid entrance of surface water and wind-driven rain. Removal of the foam may be difficult and time-consuming. Note that the window in Figure 1 was also taped. Tape is ineffective in increasing wind or wind-borne debris resistance.

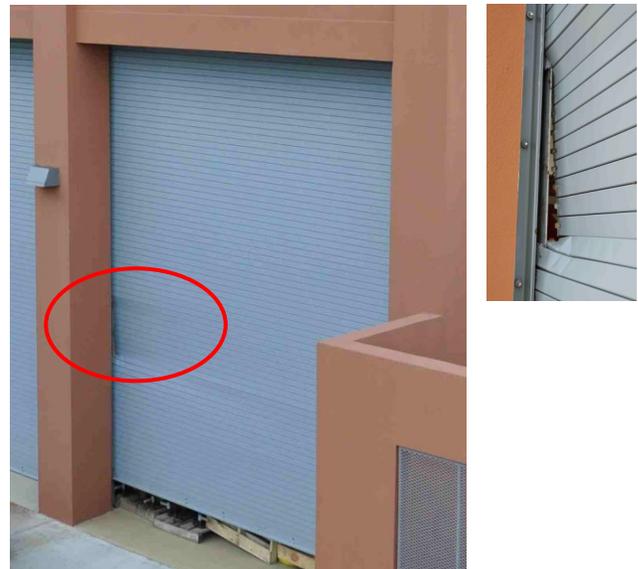
Figure 2. Rolling door damage at a new fire station.

Wind pressure failure of older sectional and rolling doors that were not manufactured to resist high wind loads is common. Surprisingly, several rolling door slats at a new fire station disengaged from their track (Figure 2). Also, two of the other five apparatus bay doors at this same fire station were not operational. The doors had a label that indicated pressure and impact resistance testing in accordance with Florida test standards, rather than DASMA test standard 115. DASMA 115 is more stringent than the applicable Florida test standards.

For added protection, design professionals should consider new personnel door and sectional and rolling door assemblies that comply with wind load testing in accordance with the *Standard Test Method for Structural Performance of Exterior Windows, Doors, Skylights, and Curtain Walls by Cyclic Air Pressure Differential* (ASTM E1233, 2014) or the Door and Access Systems Manufacturers Association International (DASMA) *Technical Data Sheet 115, Standard Method for Testing Garage Doors: Determination of Structural Performance Under Missile Impact and Cyclic Wind Pressure* (DASMA 115-17, 2017), respectively. This guidance provides additional protection above code requirements. Design professionals should also take into consideration the attachment of the door frame to the wall (e.g., type, size, spacing, and edge distance of frame fasteners) as failures have been seen between these components.

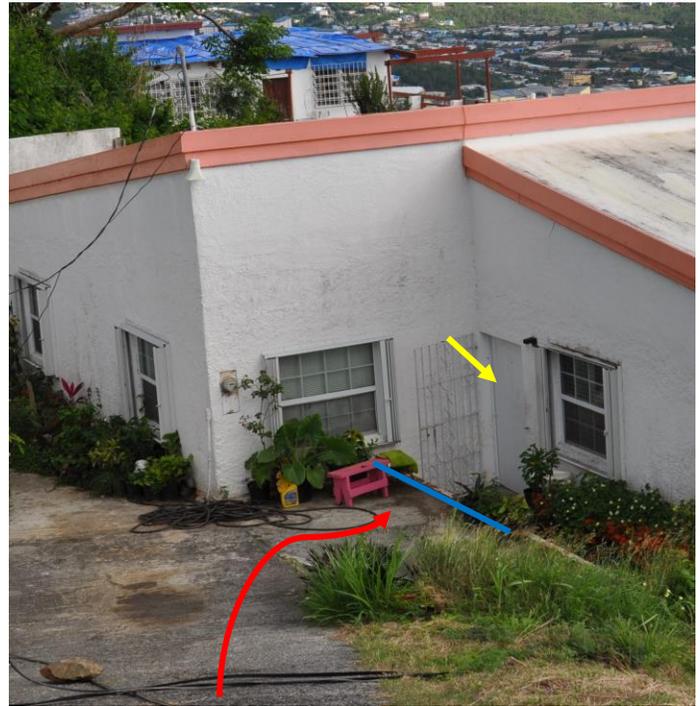
Where the topography slopes towards doors, it is recommended that the grade be reconfigured with swales and/or berms to direct surface water flow away from doors. At the house shown in Figure 3, the driveway sloped down towards the entry door. A curb directed water away from the door, but it was too short to divert all the torrential rain.

Figure 3. A substantial amount of water entered this house at the door (yellow arrow). The curb (blue line) was too short to divert the water running down the driveway.

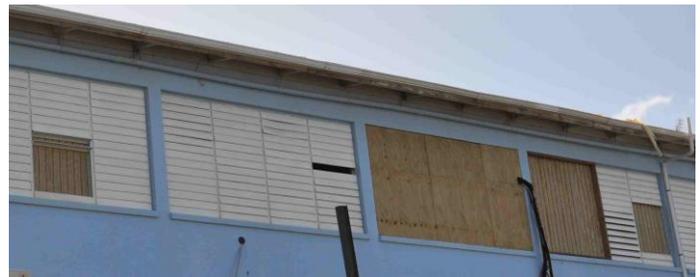
A jalousie opening has metal or glazed louvers that can be tilted to control airflow. Jalousies are common at schools, homes, and other types of buildings in the USVI. However, they are very susceptible to wind-driven rain, even when the louvers are undamaged (Figure 4). Depending upon the floor and wall construction, finishes, and location of furniture, entrance of wind-driven rain may cause limited or significant damage. If the magnitude and consequences of wind-driven rain infiltration associated with jalousies is unacceptable, fixed windows, or other types of operable windows, such as awning, casement, hopper, single-hung, or double-hung windows, can be specified.

Figure 4. Several of the metal jalousie louvers at this school were blown away.

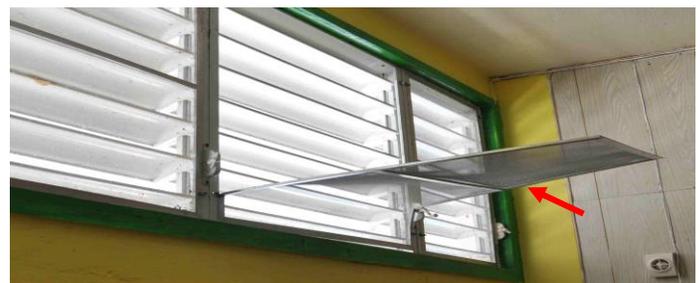
At the school shown in Figure 5, panels glazed with plastic were mounted inside the jalousies for energy conservation. Most of the glazed panels were blown away. Even when the panels remain in place, interior water leakage can occur because the panels are not typically sealed to the jalousie frame.

Figure 5. Glazed panels (red arrow) were mounted to the inside the jalousie. Such panels are typically ineffective in preventing entry of wind-driven rain.

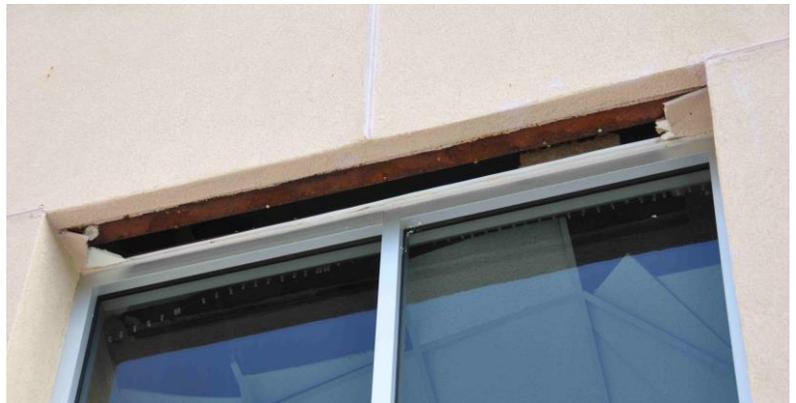
Fixed glazing assemblies are generally more resistant to wind-driven rain than operable assemblies, particularly as gaskets and seals at the operable interfaces age. Whether operable or fixed assemblies are specified, the assembly should be carefully integrated into the wall system. Figure 6 is an example where windows were replaced after Hurricane Marilyn (1995) with glazing systems that provided wind-borne debris and high wind pressure resistance. However, during Hurricane Irma, some of the wall covering blew away, and wind-driven rain entered the hospital. In addition, one window assembly blew into the facility, apparently due to inadequate attachment of the window frame to the wall framing.

Figure 6. Blow-off of the wall covering at the window head recess at a hospital allowed entrance of wind-driven rain.

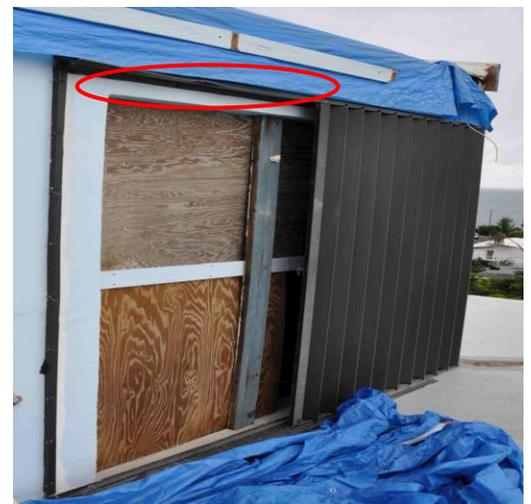
It is recommended that only shutters bearing a label indicating that they have been tested and are building code compliant be installed. Figure 7 shows a damaged shutter without a label indicating whether it was a tested assembly. It is possible that the shutter experienced loads that exceeded those specified in the test standards, or it may not have been a tested assembly.

Figure 7. The red oval indicates where the head track was deformed. Plywood was temporarily installed after the storm.

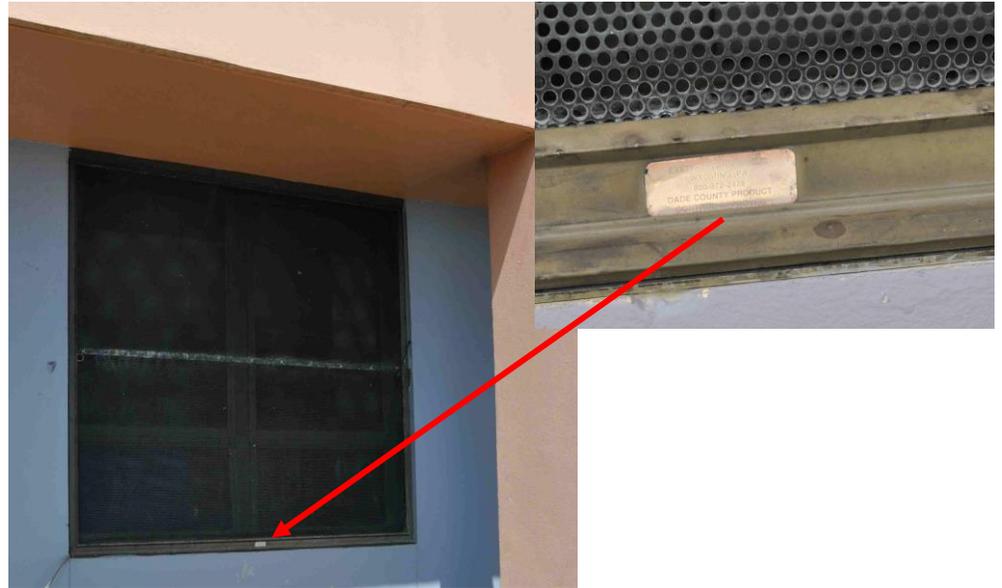
Figure 8 illustrates a permanently mounted screen shutter. With this type of shutter, future deployment time and costs are eliminated.

Figure 8. Permanently mounted wind-borne debris-resistant screen at a medical clinic. The inset shows a close-up of the screen and a label indicating that the shutter was a tested assembly.

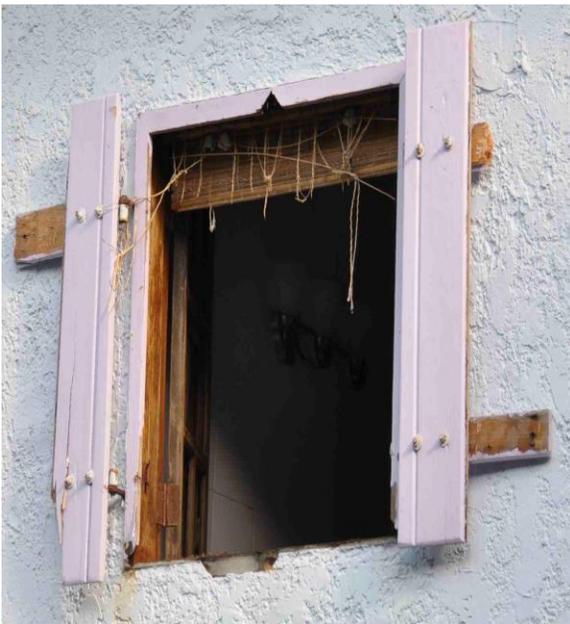
Hurricane Shutter Design Considerations for Florida, published by APA – The Engineered Wood Association (APA T460, 2013), provides guidance for constructing and installing wood panel shutters. If wood panels are installed, it is important to adequately anchor them so that they do not become wind-borne debris. Figure 9 shows traditional shutters made from thick wood boards. This type of shutter provides substantial resistance to wind-borne debris, provided the hardware and connecting bolts are not corroded and the shutters are adequately latched. As shown in Figure 9, the boards were inadequately bolted.

Figure 9. Damaged traditional-type shutter.

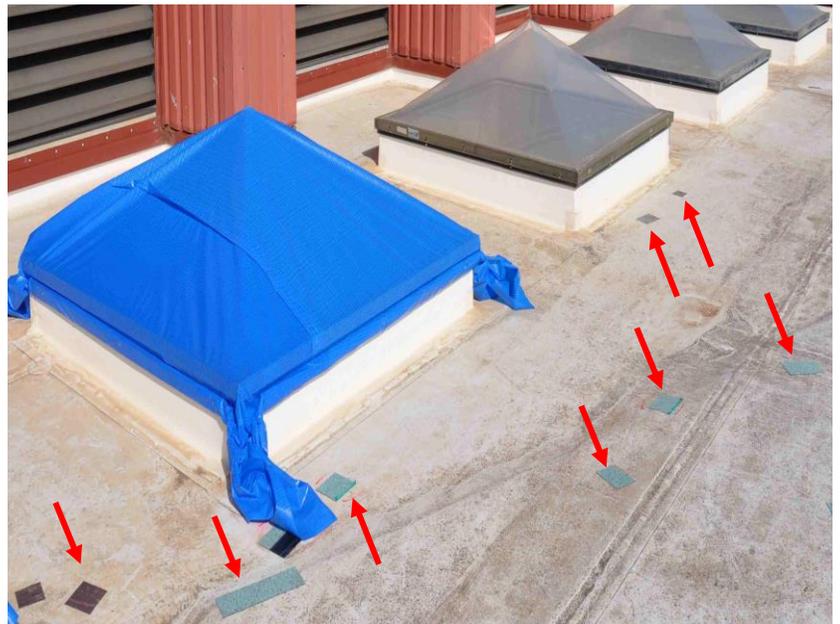
Skylights are also required to meet wind pressure and wind-borne debris criteria. At the airport terminal building shown in Figure 10, the skylights appeared to be adequately attached to their curbs, although some of the screws were corroded. A few of the skylights were broken by wind-borne debris, illustrating the importance of specifying skylights that have been tested to meet wind-borne debris criteria.

Figure 10. Skylight damaged by wind-borne debris. The red arrows indicate patches where debris punctured the roof membrane.
